MEMORANDUM

Re: Revised Post-TCRA Semi-Annual Inspection Report - July 2014 Inspection

This document reports the results of the July 2014 inspection of the armored cap cover, fencing, and signage installed for the Time Critical Removal Action (TCRA) at the San Jacinto River Waste Pits Superfund Site (TCRA Site). This document supersedes the Post-TCRA Semi-Annual Inspection Report - July 2014 Inspection, dated August 11, 2014.

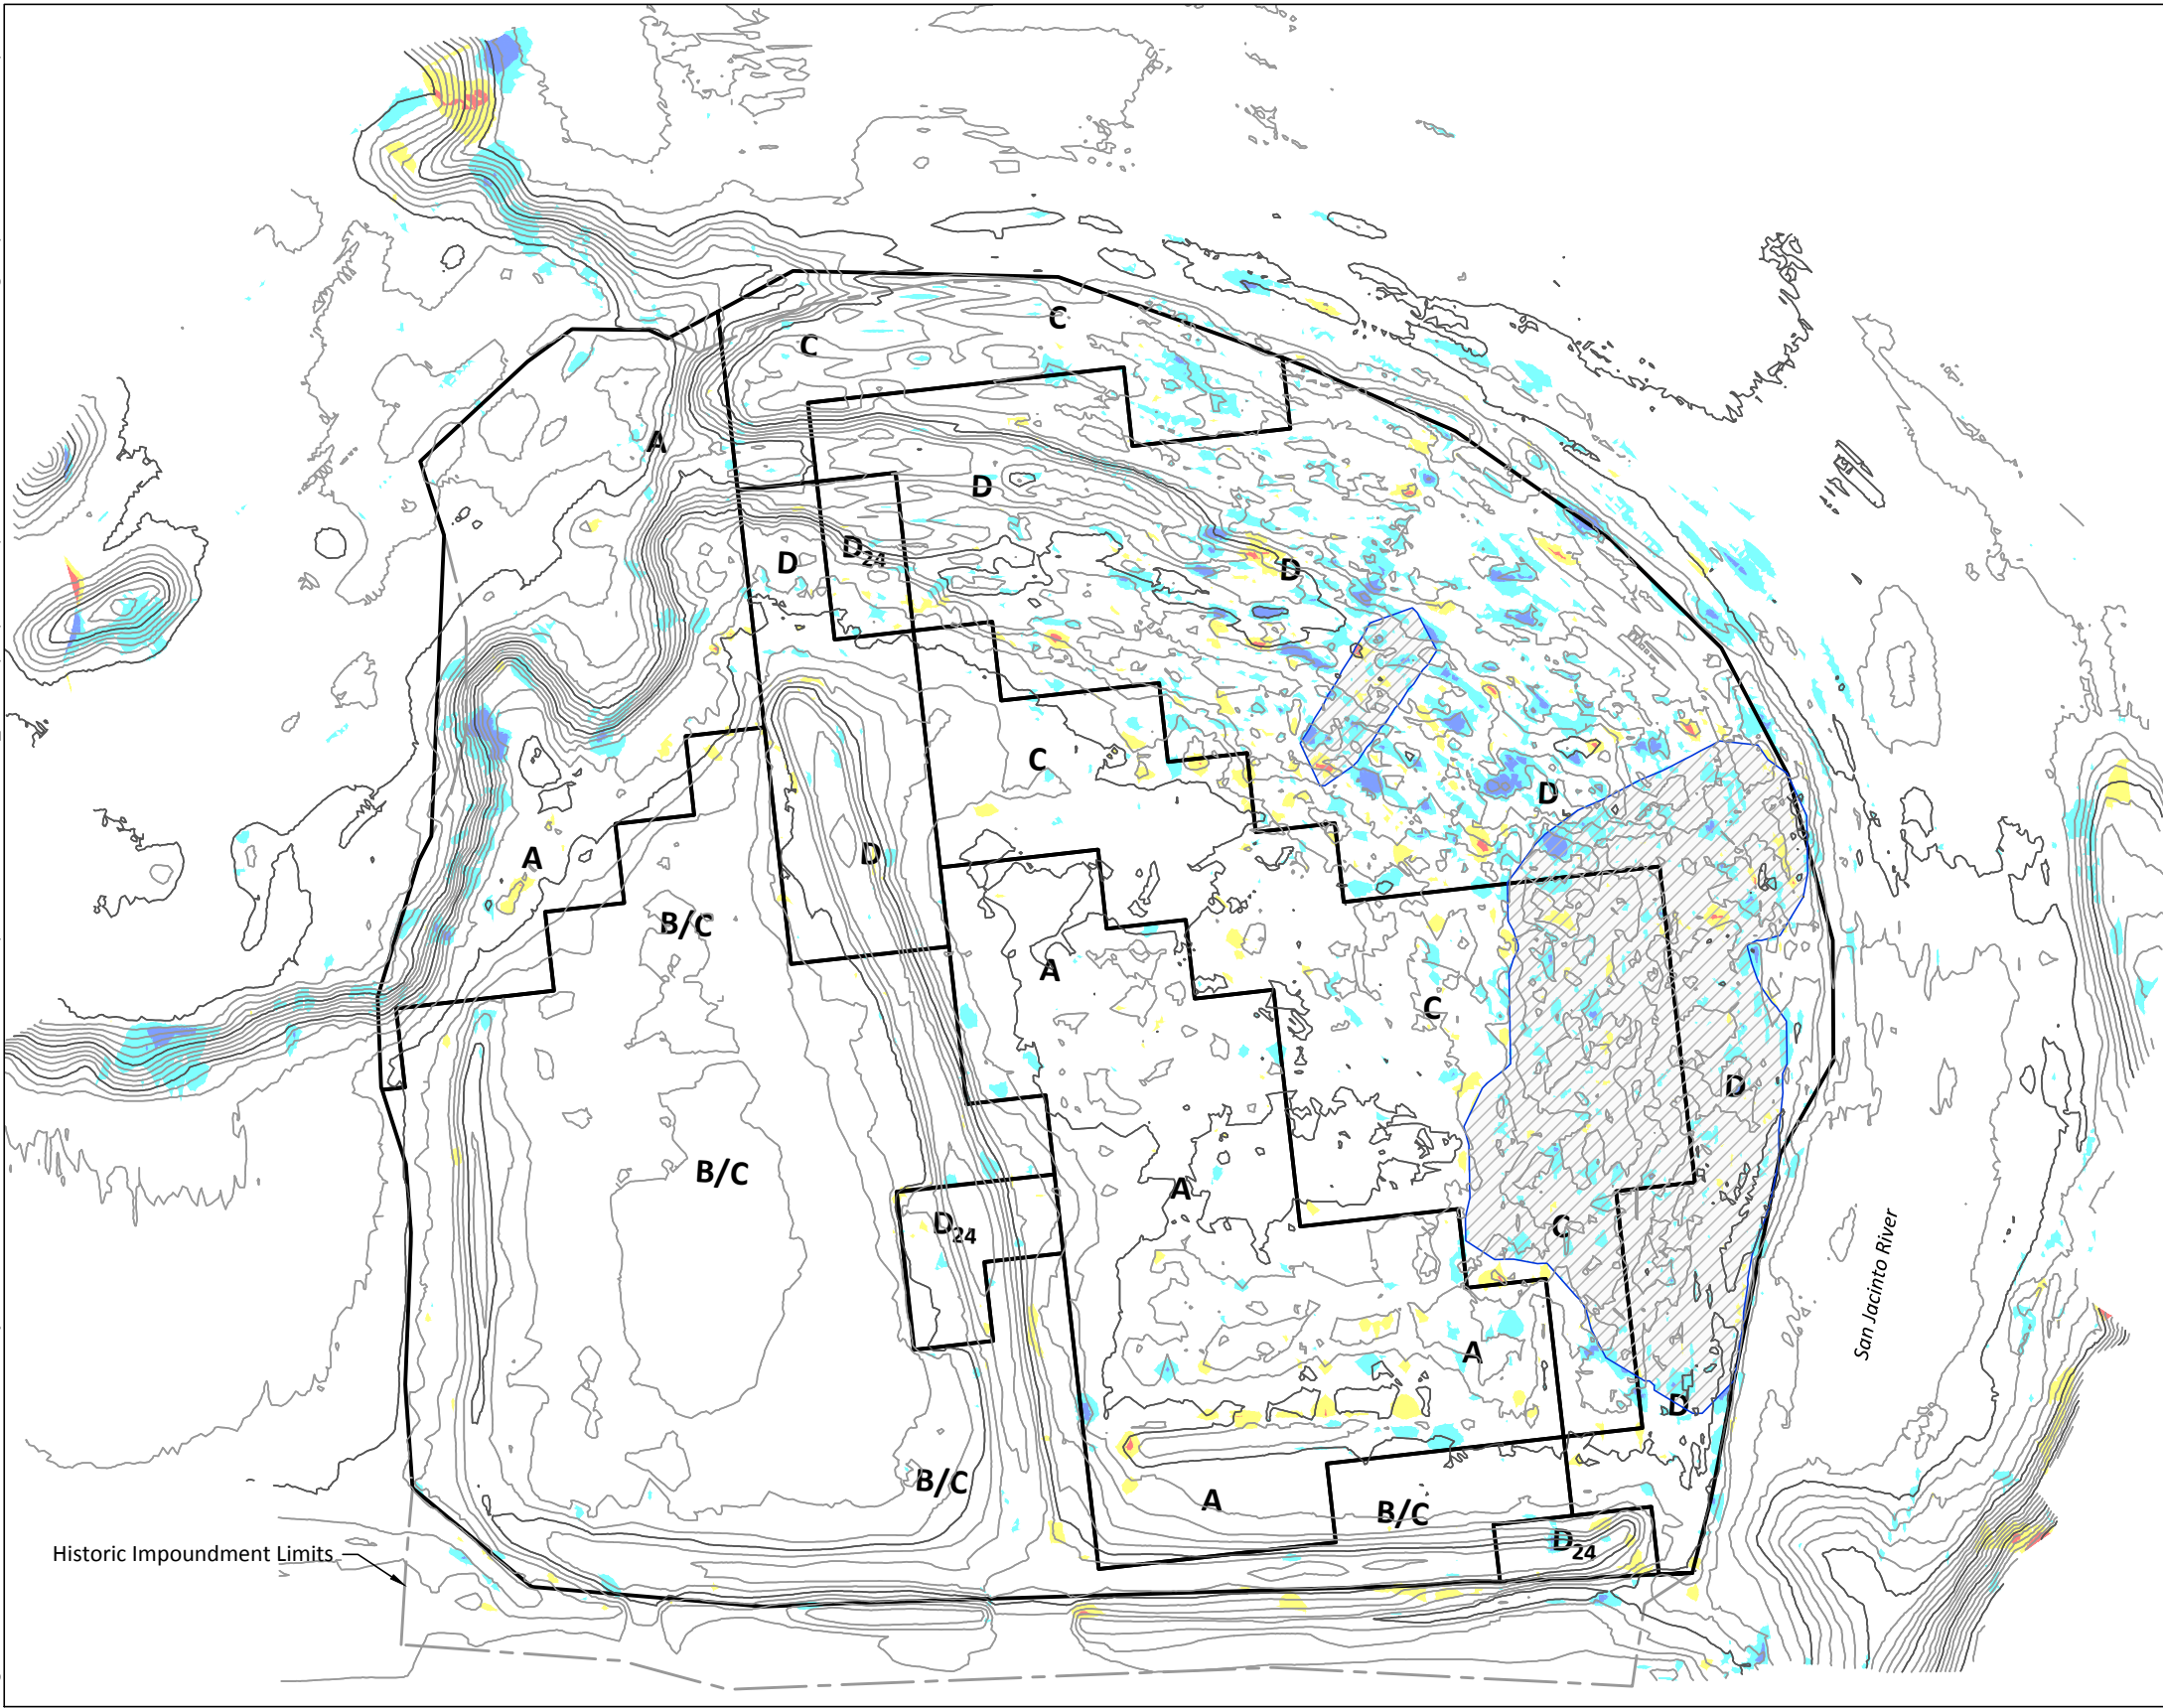
Figure 3 – July 2014 Semi-Annual Inspection Survey

The armored cap was enhanced by adding additional armor rock where slopes exceeded 3 horizontal/1 vertical, in January 2014 (Anchor QEA 2014). A survey was conducted in February 2014 following completion of the enhancement work. With the one caveat mentioned below, the survey data from July 2014 and February 2014 post-enhancement surveys were compared to evaluate the differences in the top of the armored cap elevation between surveys (Anchor QEA 2014). These differences are shaded and shown in Figure 3.

In February 2014, the hatched areas on Figure 3 could not be accessed by boat during the survey in February due to continued frontal systems causing low water conditions, and furthermore, in February 2014, the presence of organic growth within the hatched areas did not allow a wading survey to be conducted safely (Anchor QEA 2014). The July 2014 survey data within the hatched areas on Figure 3 were therefore compared to the most recent survey data for that area, from October 2013, to evaluate differences in the top of the armored cap elevation between those two surveys for those areas. The differences between the July 2014 and October 2013 survey data for the hatched areas are shaded and shown on Figure 3.

The survey results generally indicate continued sedimentation/deposition on the surface of the armored cap in submerged areas. The results do not indicate any loss of cap material.

The small areas identified as increases and decreases in elevation, outside of the enhancement areas, can be attributed to the horizontal and vertical limitations of the survey, minor shifts in track line location from the baseline survey, and elevation data recorded in the crevices between rock surfaces. The potential for these types of variations between the two datasets to exist was confirmed by the surveyor after reviewing the data collected during this inspection versus the post-enhancement surveys taken in February 2014 and the October 2013 survey.

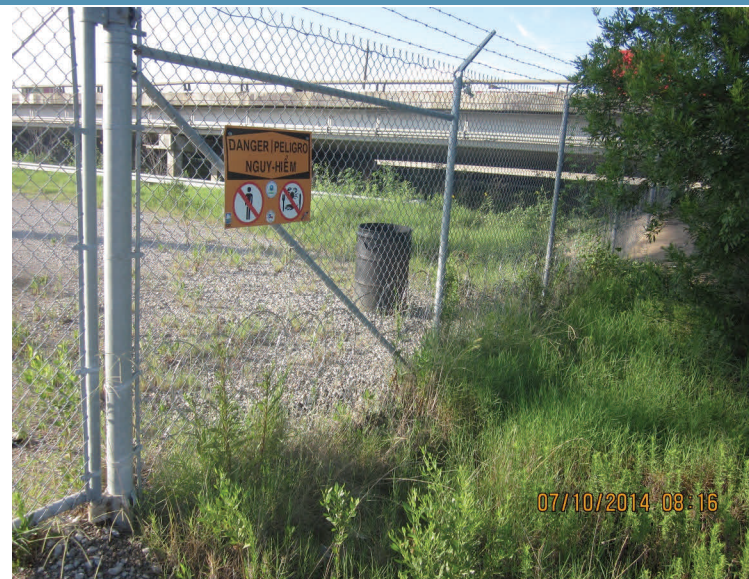
A breach in the perimeter fencing had been observed on June 17, 2014, north of and adjacent to I-10 on the west bank of the San Jacinto River. Repairs were made on June 20, 2014, by reattaching the chain link fence to the fence post. Barbed wire was also added along the lower portion of the perimeter fencing between the access gate and I-10 (see Photographs 2 and 3).

Photograph 02: Perimeter fencing adjacent to access gate north of I-10 with recently added barbed wire along bottom portion (view southeast)

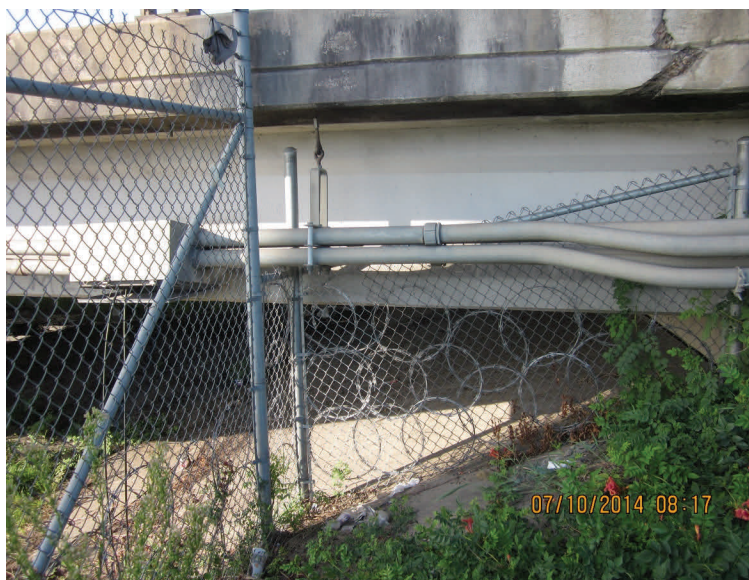
Photograph 03: Repaired fencing north of and adjacent to I-10 (view south)

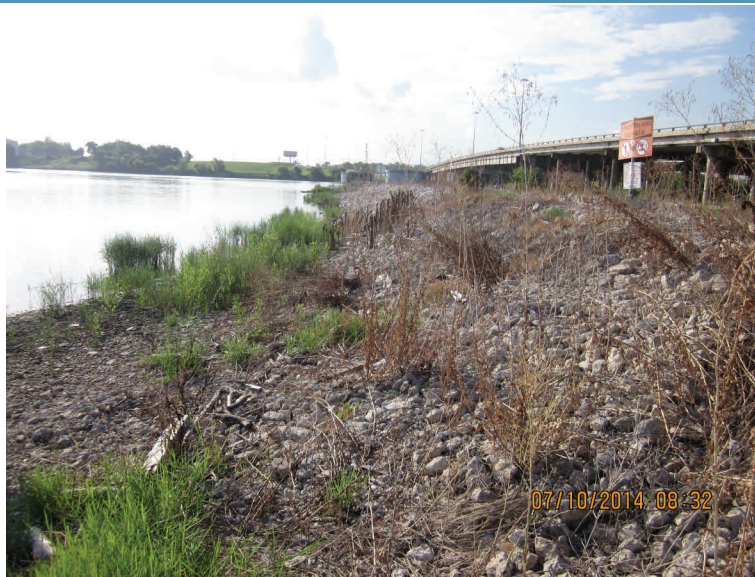
Grassy vegetation was observed around some intertidal areas of the Western Cell perimeter (see Photographs 5 through 6 and 8 through 10 in Appendix A). Following USEPA's notification and approval on May 28, 2014, vegetation was treated on July 15, 2014, using the vegetation control measures outlined in a letter to USEPA dated July 12, 2013 (Anchor QEA 2013).

Photograph 05: Vegetation and warning signs along southern berm (view east)

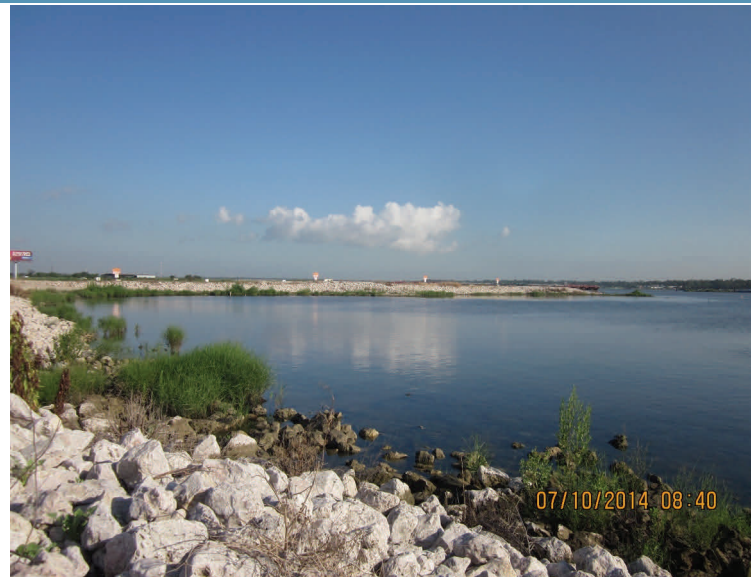
Photograph 06: Southern and central berms (view northwest)

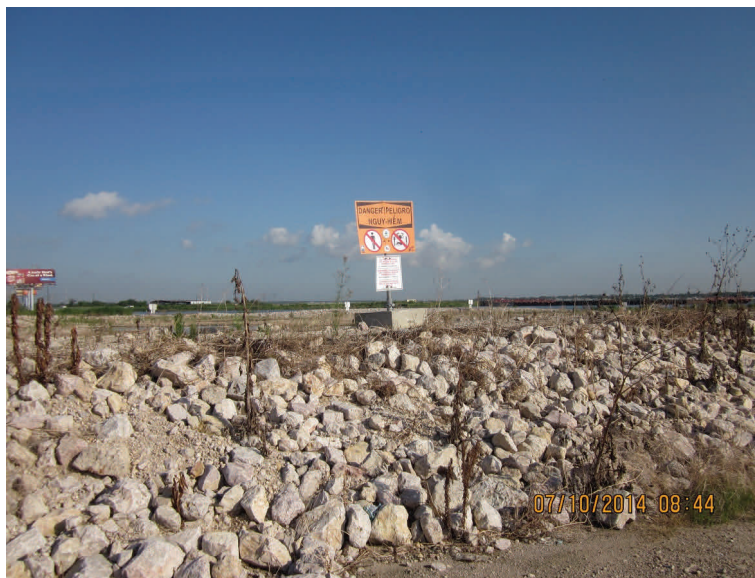
Photograph 07: Warning sign and dying vegetation along central berm (view west)

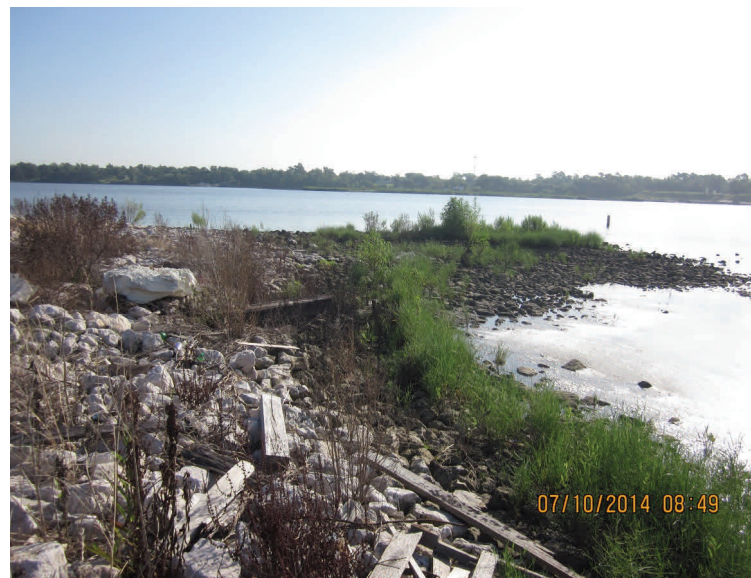
Photograph 08: Vegetation along northeastern end of central berm and warning buoy north of Eastern Cell (view northeast)

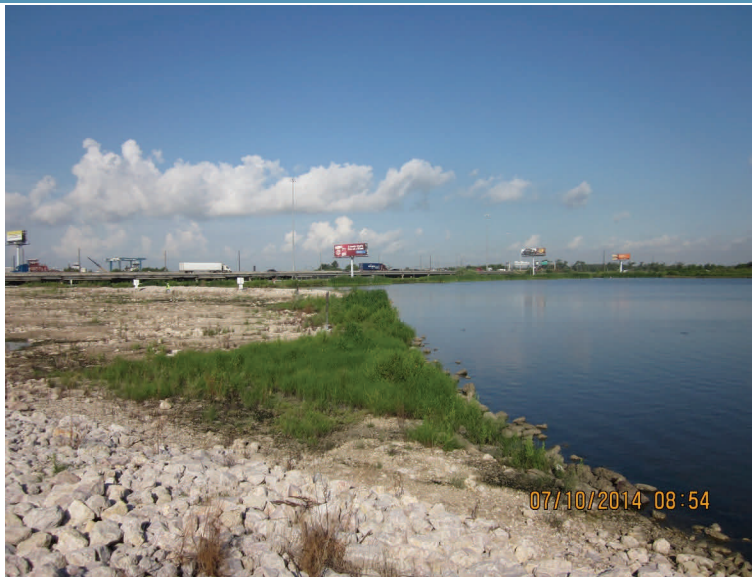
Photograph 09: Vegetation along northern edge of Western Cell (view southwest)

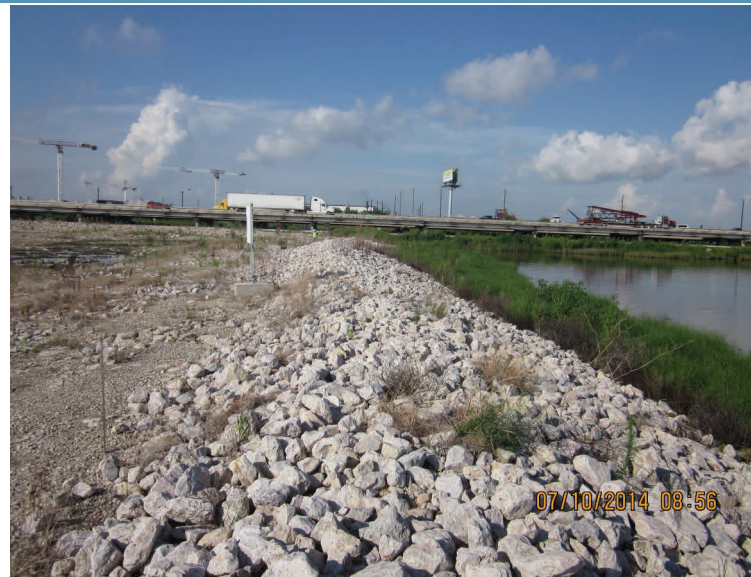
Photograph 10: Warning signs and vegetation along western berm (view south)
